# Planning & Construction of Temp Works for Emergency Slope Works at Sai Wan Road

Director, Geotech Engineering Ltd.

- Contract No. GE/2013/29 – Term Contract in LPMit Programme
- Contract Sum Approx. HK\$110M in 30 months
- The Engineer – LPM3 Division, GEO, CEDD
- Main Contractor – Geotech Engineering Ltd.

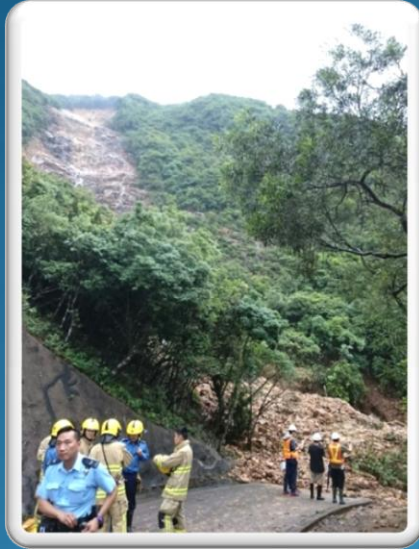
**SW 1**

**Landslide volume approx. 2100 m<sup>3</sup>, equivalent to that of 1 standard swimming pool**

Install 3 layers of flexible barriers (FB01, FB02 & FB03) at SW1

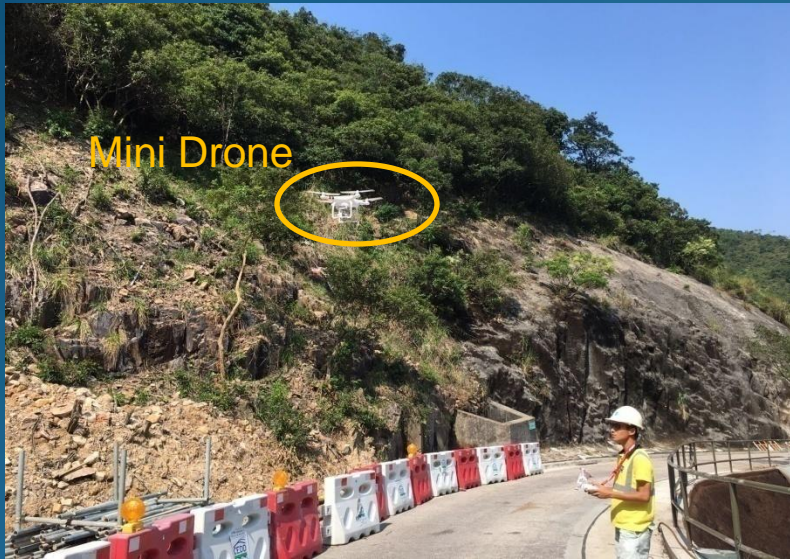
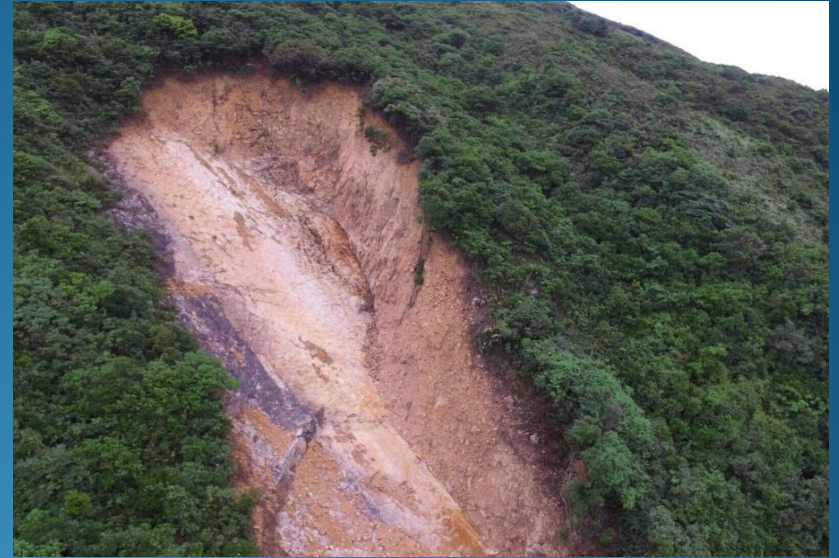
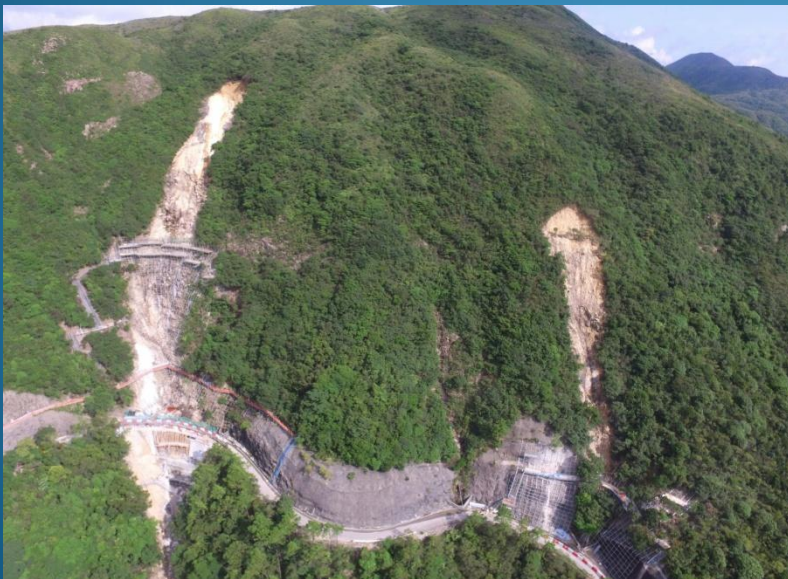
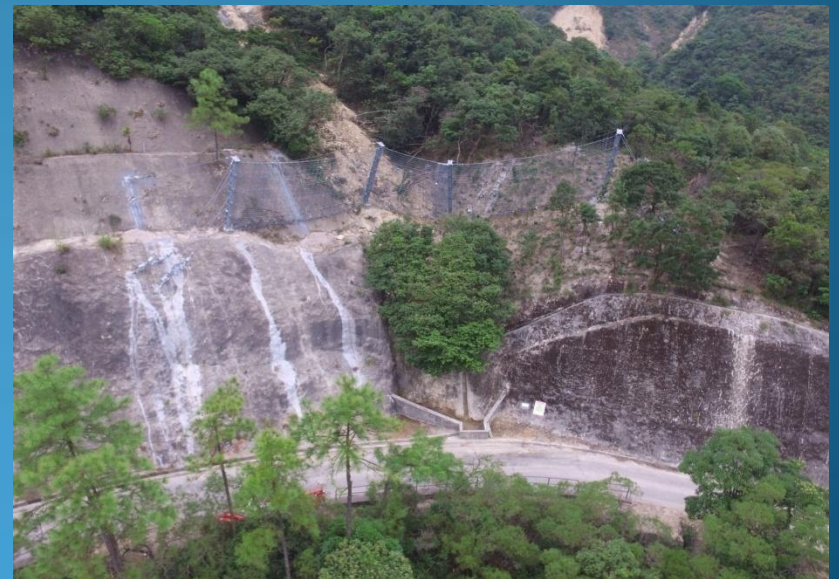
Use drone to take aerial photos to monitor the situations of the scars daily and right after adverse weather
