# BIM-AM-RS

## Adopting Building Information Modelling - Asset Management to Enhance Railway Safety

Mr. Chris Ho- Senior Engineer  
Electrical and Mechanical Services Department  
The Government of Hong Kong  
Special Administrative Region

22 May 2019

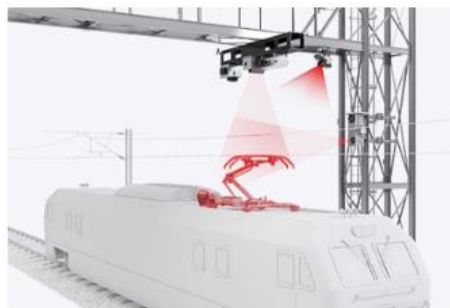
ON-LINE MONITORING OF CONDITION OF TRAIN PANTOGRAPH AND OVERHEAD LINE

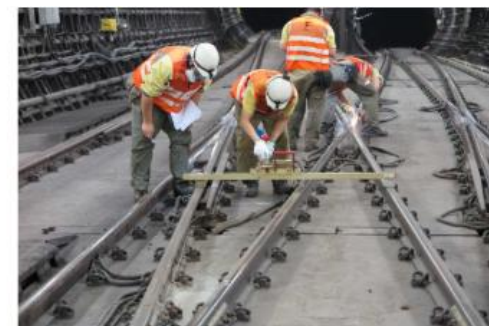
ON-LINE MONITORING AND DETECTION OF RAIL WIDTH TO PREVENT DERAILMENT

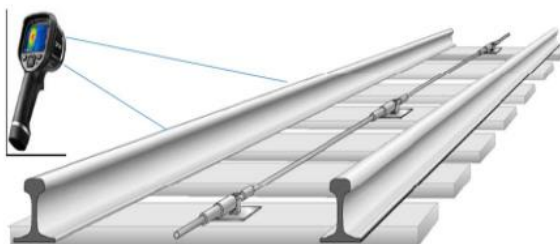
AUTOMATIC DETECTION OF RAIL CRACK TO ENSURE PASSENGER SAFETY

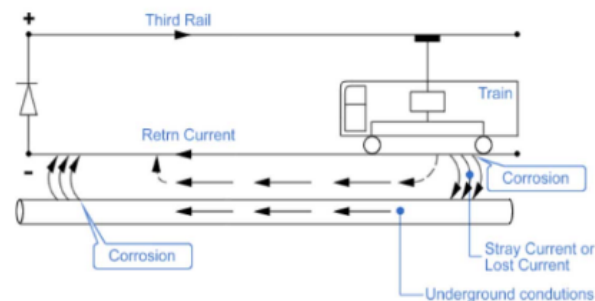
SMART DC STRAY CURRENT MONITORING AND REDUCTION IN RAILWAY SYSTEM

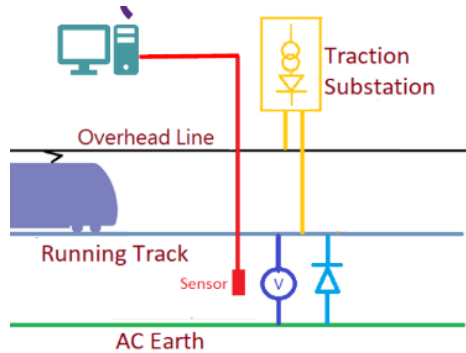
Stray Current

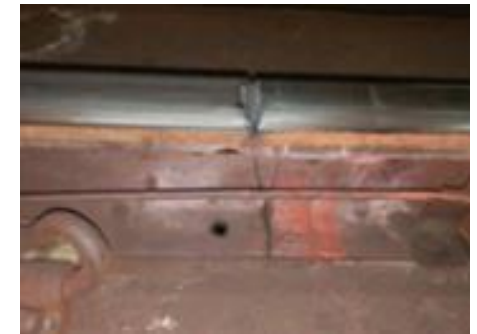
Rail Crack Monitoring using Fiber Optic based Ultrasonic Guided Wave (UGW)

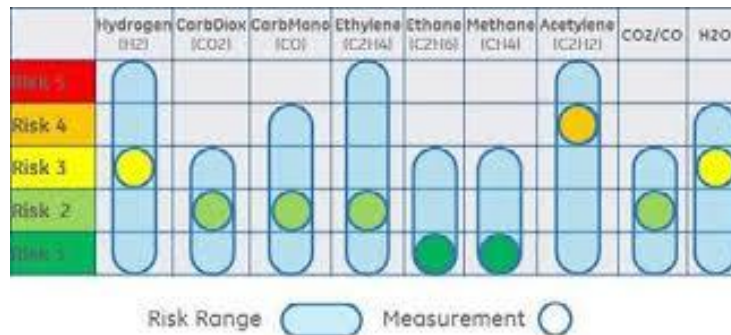
Dissolved Gas Analysis (DGA) Monitoring

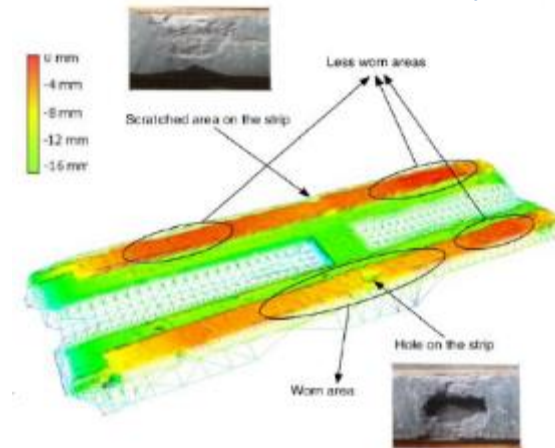
Pantograph Monitoring

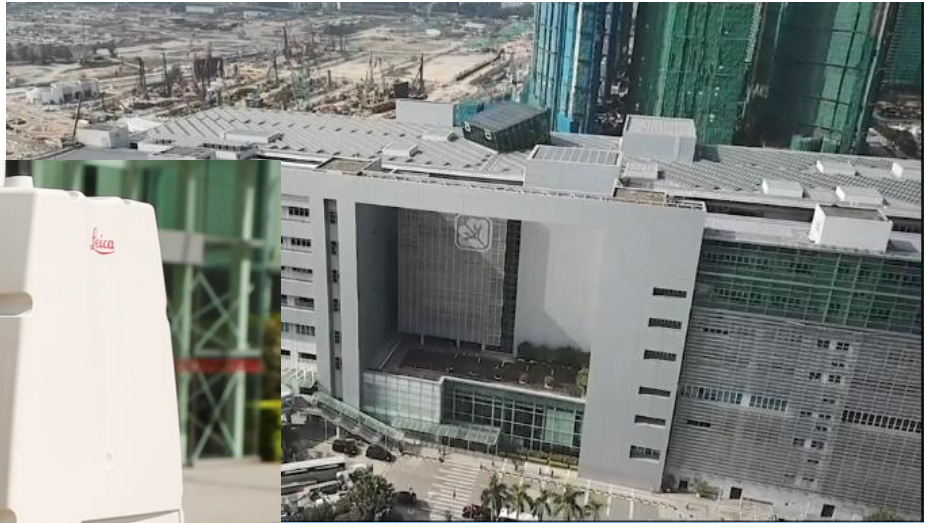
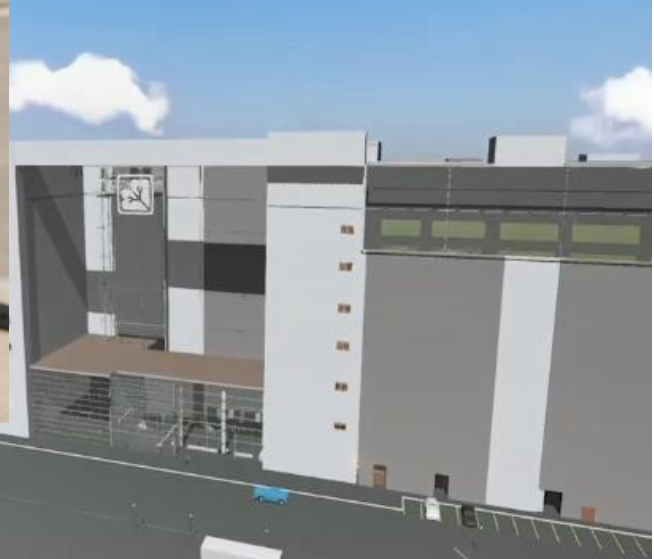
*Site Survey: Exterior of the Building*

In this project, we adopt 3D laser scanners for site survey, analysis and recording

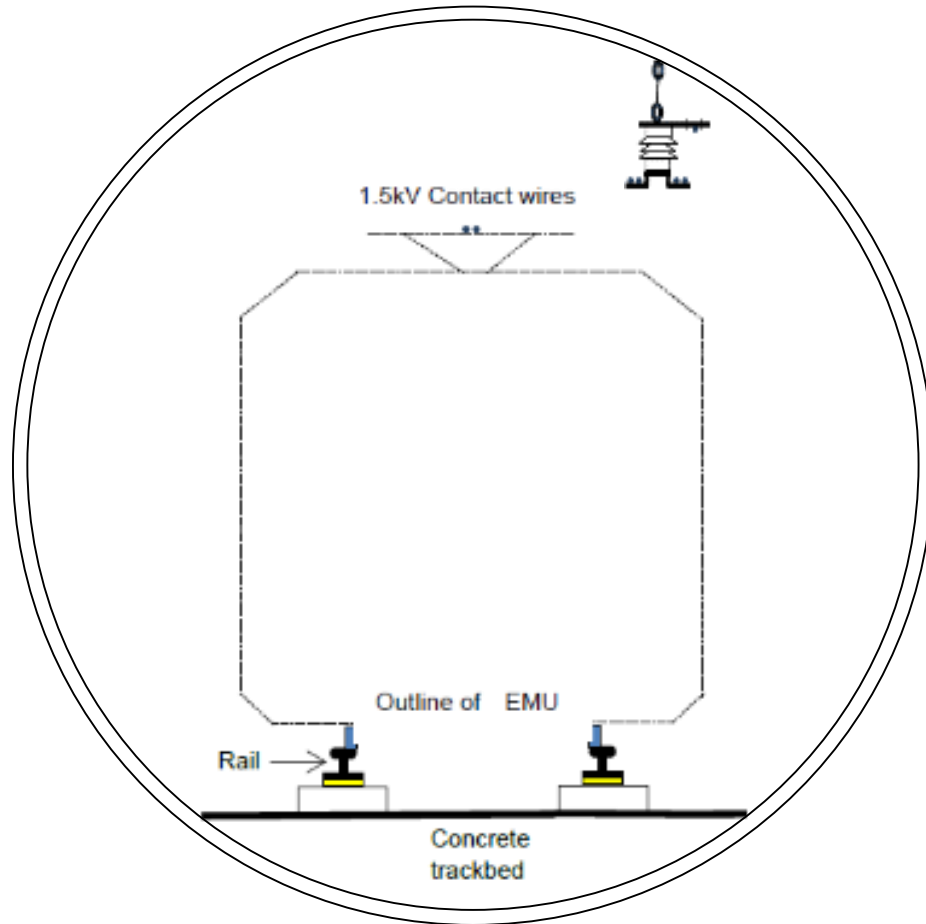
# Stray Current

## Asset Attributes

Asset ID : 00168	
Attributes	Values
Make/Model	Dummy 456
Type	Rail Insulation Pad
Year of service	9
Location	CTL Down Km 107.360

## Stray Current

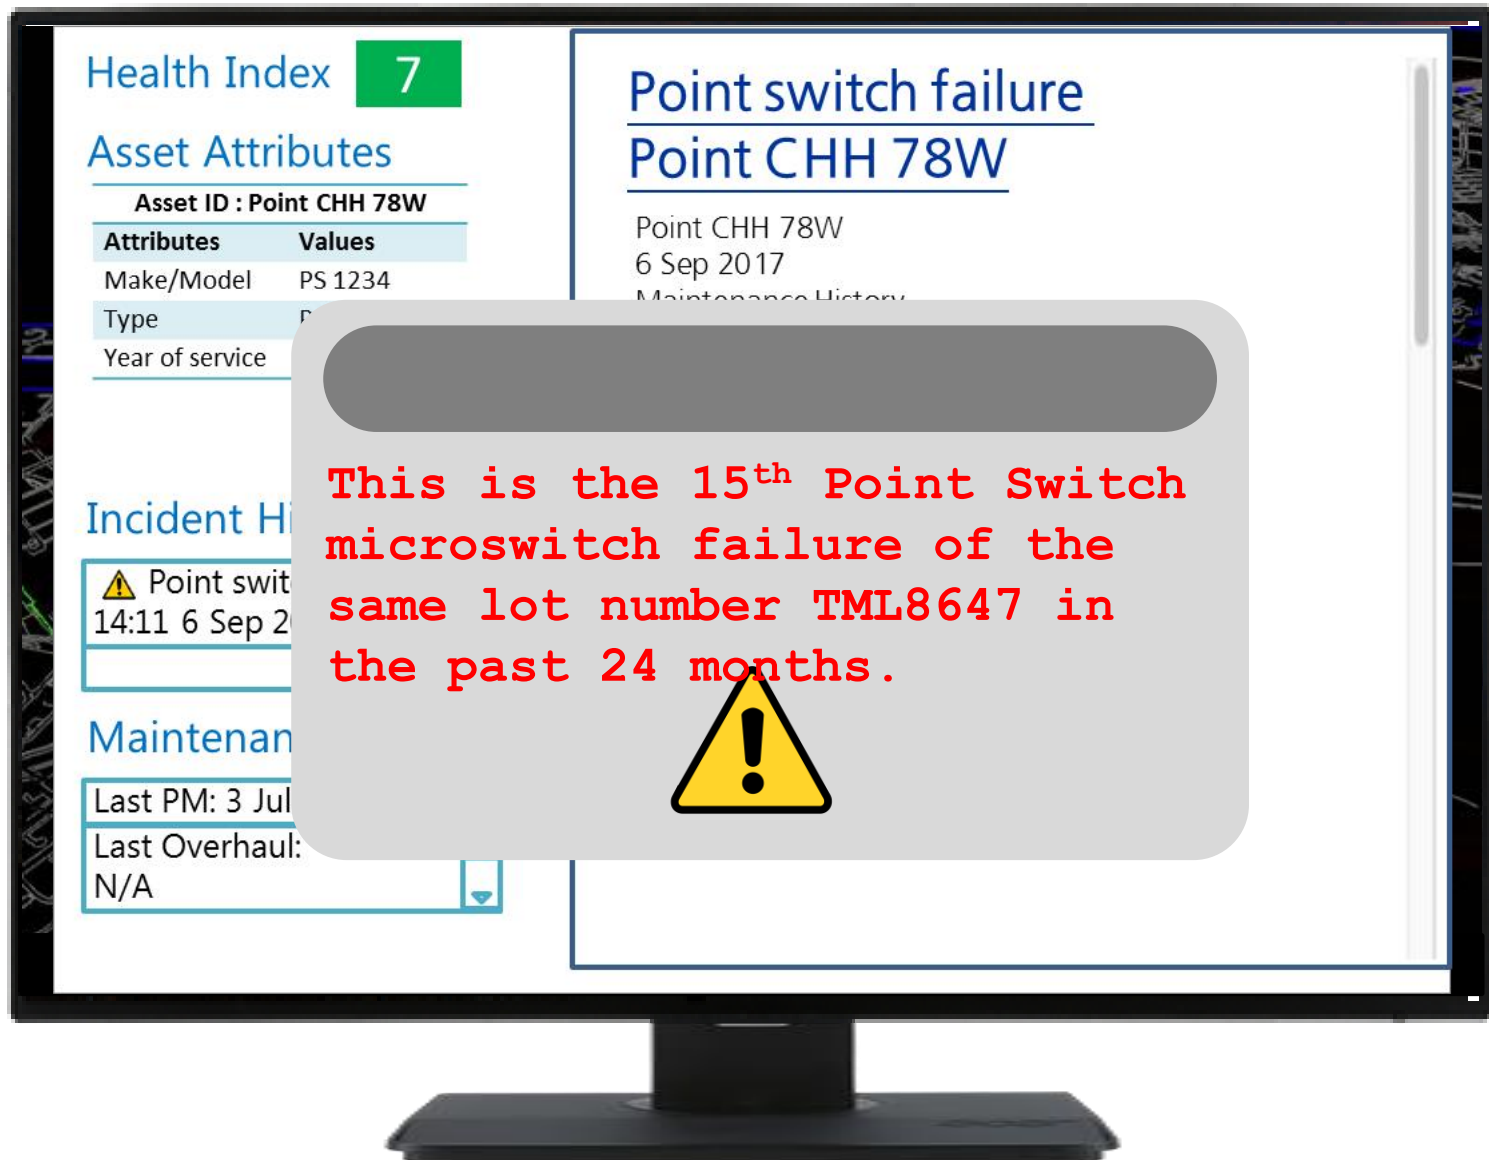
# Point Switch

**This is the 15<sup>th</sup> Point Switch microswitch failure of the same lot number TML8647 in the past 24 months.**

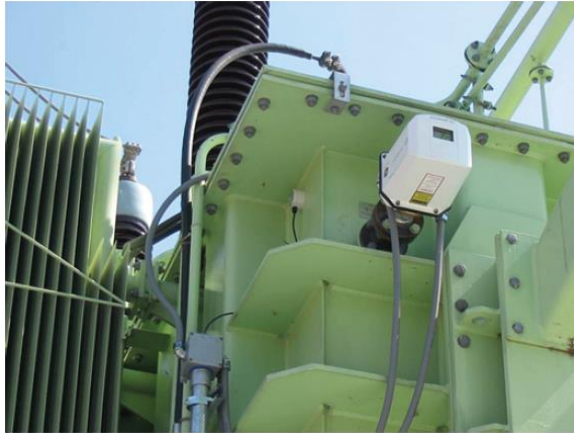
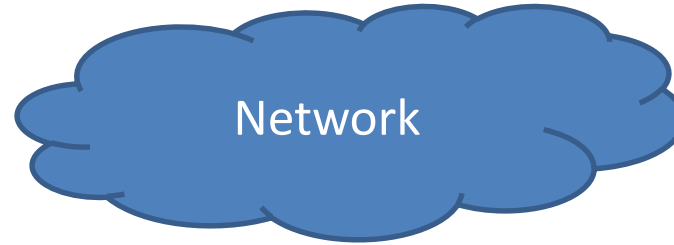
# Online DGA Monitoring in

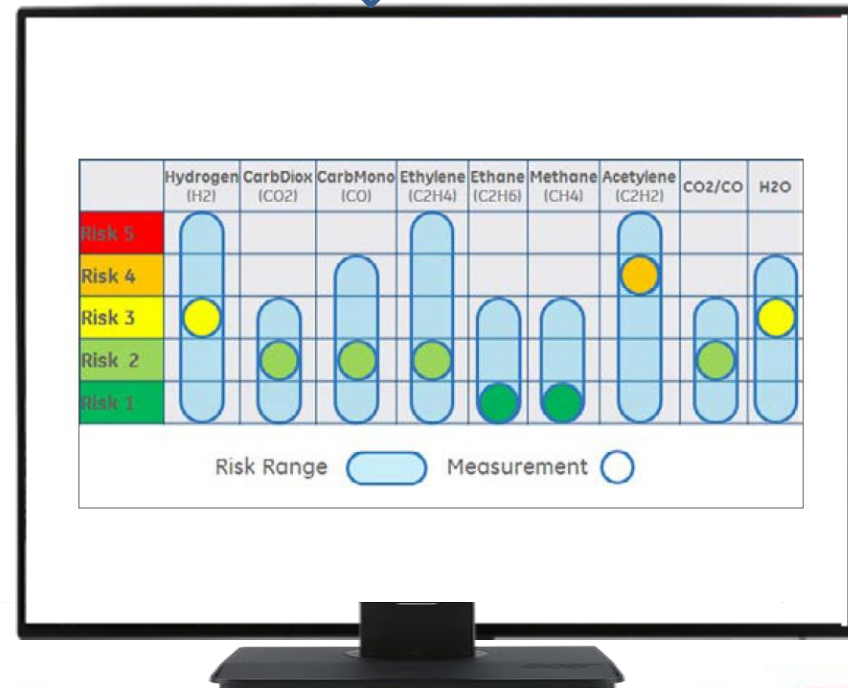
*Online DGA Data*

GAS	NAME	CONDITION RESULTING IN GAS PRODUCTION
H <sub>2</sub>	Hydrogen	Nearly <b>all fault conditions</b> , low energy PD
CH <sub>4</sub>	Methane	Oil overheating between 200 and 500°C
C <sub>2</sub> H <sub>6</sub>	Ethane	Oil overheating between 300 and 500°C
C <sub>2</sub> H <sub>4</sub>	Ethylene	Oil overheating over 500°C, possible formation of carbon particles
C <sub>2</sub> H <sub>2</sub>	Acetylene	Electrical <b>arcing</b> , Oil > 800°C, strong formation of carbon particles, <b>metal</b> melting
CO	Carbon Monoxide	<b>Paper</b> insulation overheating
CO <sub>2</sub>	Carbon Dioxide	Severe oil oxidation, <b>paper</b> degradation
O <sub>2</sub>	Oxygen	Oxidation, <b>leak</b>

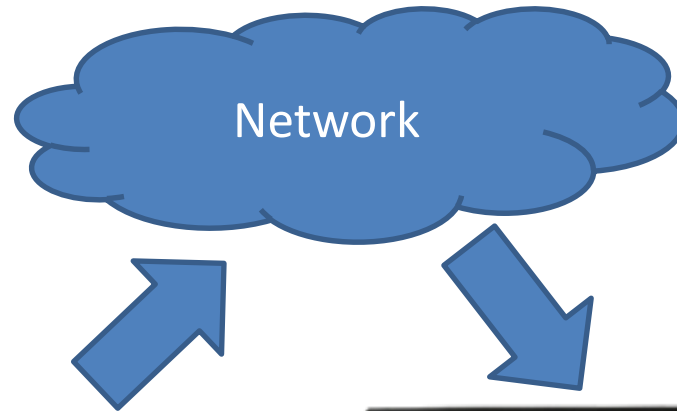
*Online PD Data*

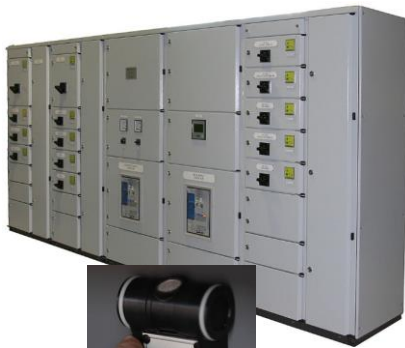
*PD Local  
Monitoring  
Device*

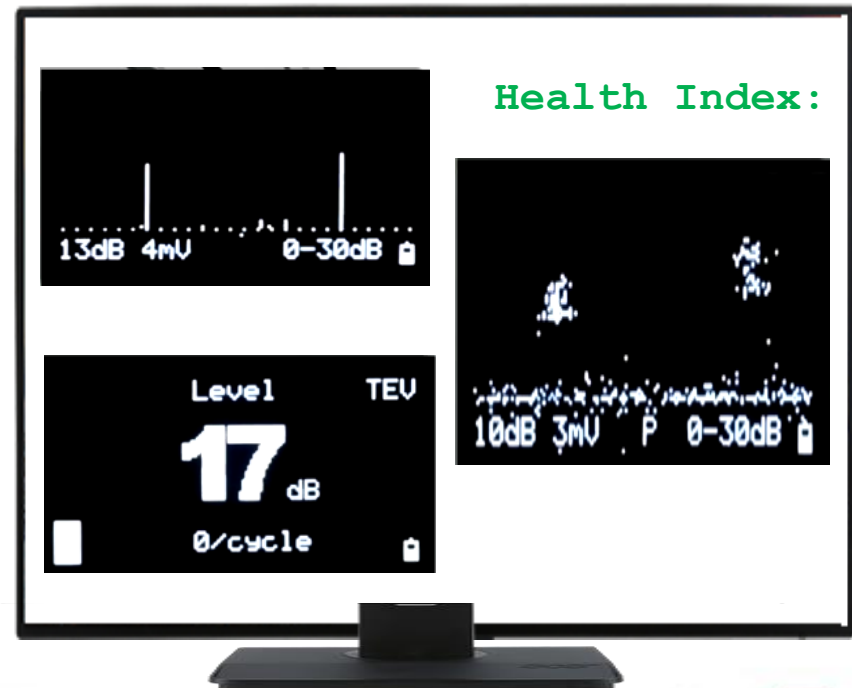
*PD Sensor*

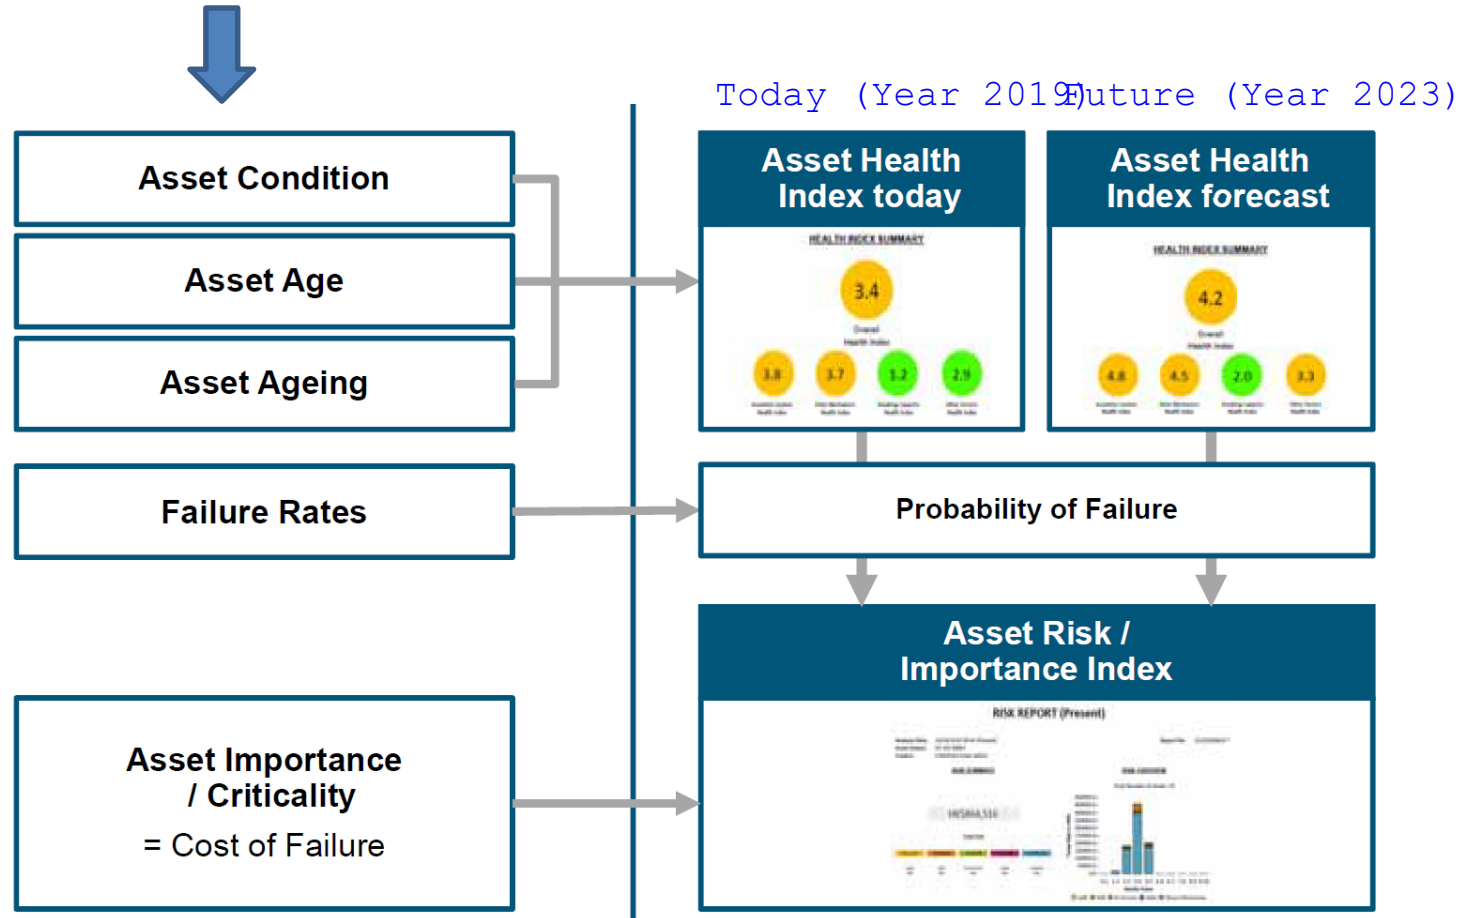
# AI/Data Analytic in BIM-AM-RS

Online DGA & PD Data
