# **Temporary Works Excellence Award 2017 Presentation**

**Contract No. CV/2012/08  
Liantang / Heung Yuen Wai Boundary Control Point Site  
Formation and Infrastructure Works – Contract 2**

# Temporary Work for Tunnel Enlargement Excavation

## The Largest Scale Enlargement on the Curved Princess Hill Section

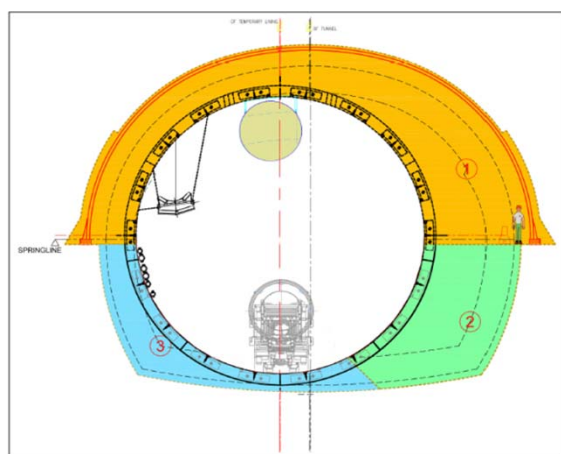
1. PILOT TBM TUNNEL BORING

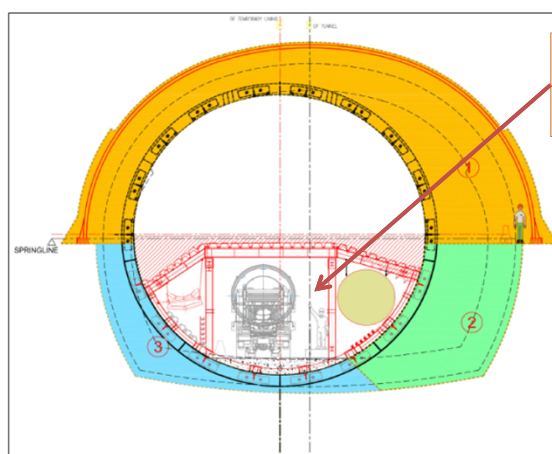
2. TEMPORARY WORK SERVICE GALLERY ERECTION

- ✓ First of this kind to enlarge from a TBM driven Tunnel to wide span tunnel
- ✓ Temporary Works - Large Scale Platform - approx. 360m long structural steel gallery inside the tunnel maintaining uninterrupted logistics supply, utility services, ventilation, spoil conveyor from TBM excavation.

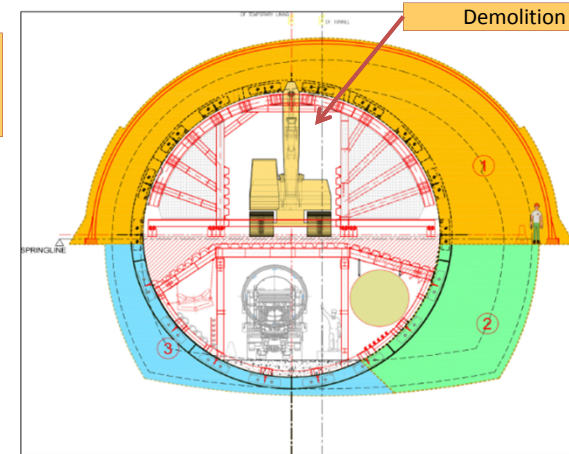
3. TOP HEADING WITH TEMPORARY WORK – SEGMENT CATCHING FRAME

- ✓ Over 1,000 tons of steel
- ✓ Temporary Works - Segment catching frame and cushions was designed to minimize the impact load from falling of demolition material.

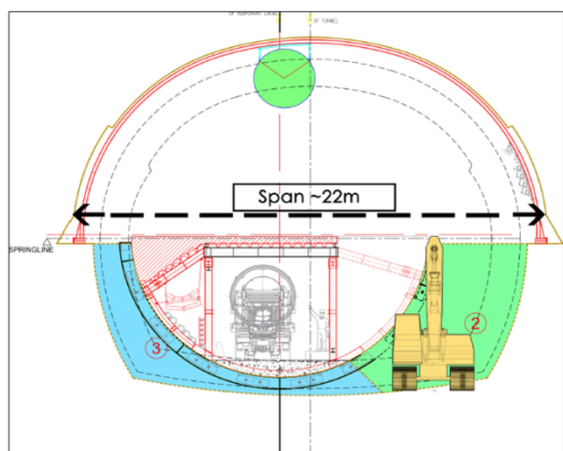
4. BENCH RIGHT HAND SIDE ENLARGEMENT

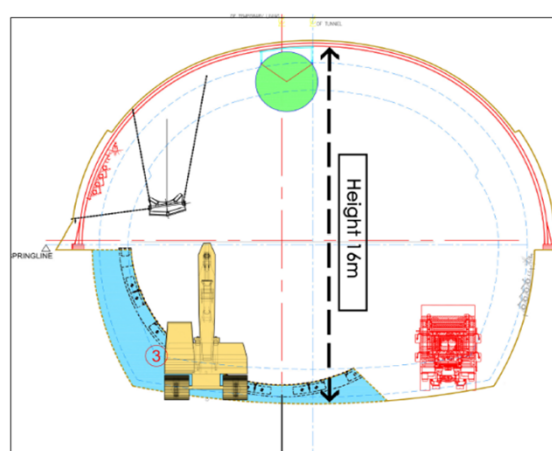
5. BENCH LEFT HAND SIDE ENLARGEMENT

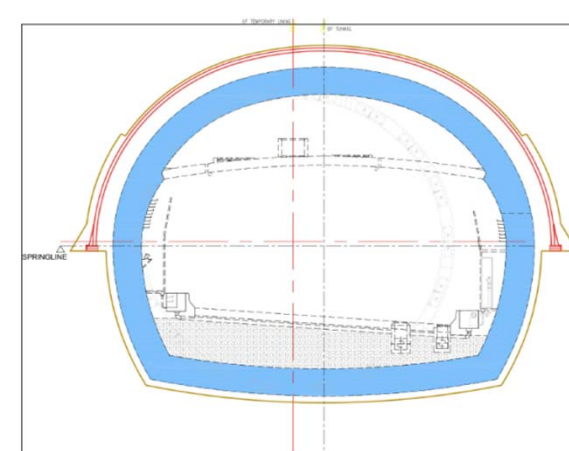
6. CONSTRUCTION OF PERMANENT WORKS

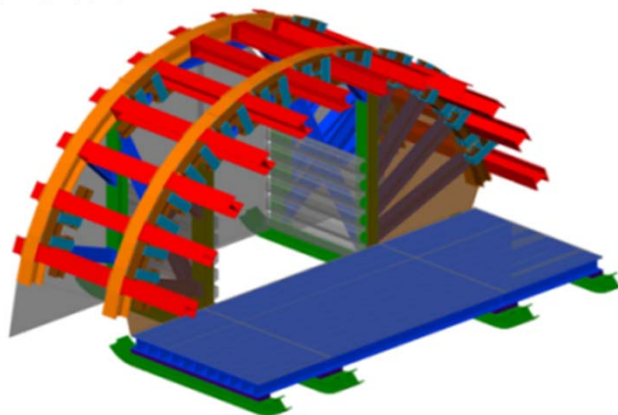
Since the impact time is unknown, reference was made to the attached test regarding impact of a 4000kg mass falling at 7.5m height onto a damping system and the first impact force is found to be around 1866kN.

By comparing the mass of a segment and different falling height with the said test, a proportionate impact force is determined. The maximum falling height of a TBM segment is limited to 1m. The test for a 4000kg object utilizes 7.5m falling height. Thus, the calculation of an object falling at 7.5m and 1m at rest will have final velocities of 12.1m/s and 4.43m/s respectively.

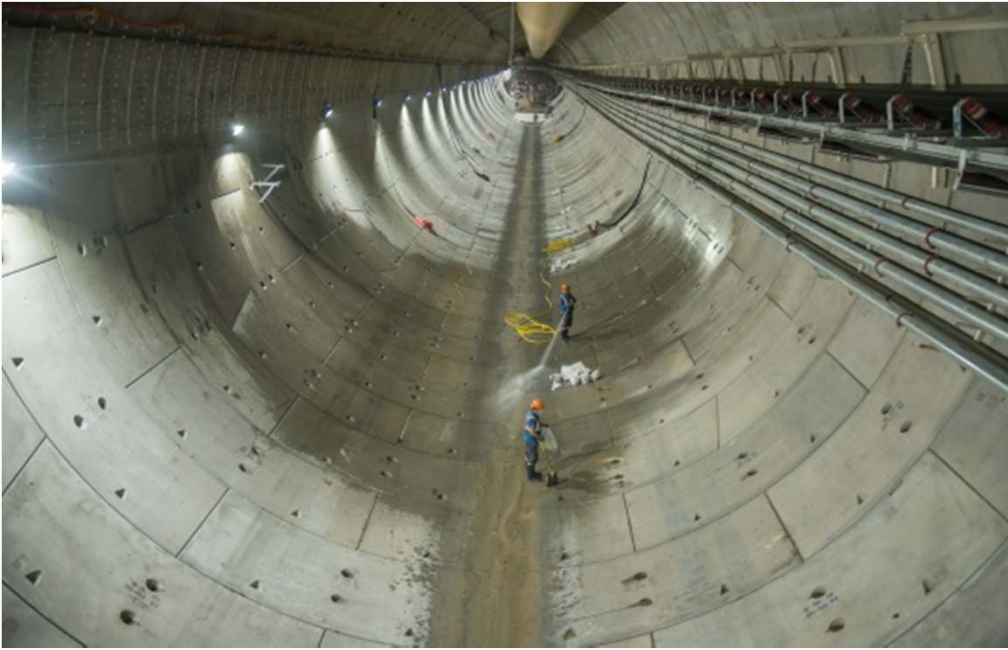
Photo 1 – TBM Segmental Lined Tunnel before Enlargement

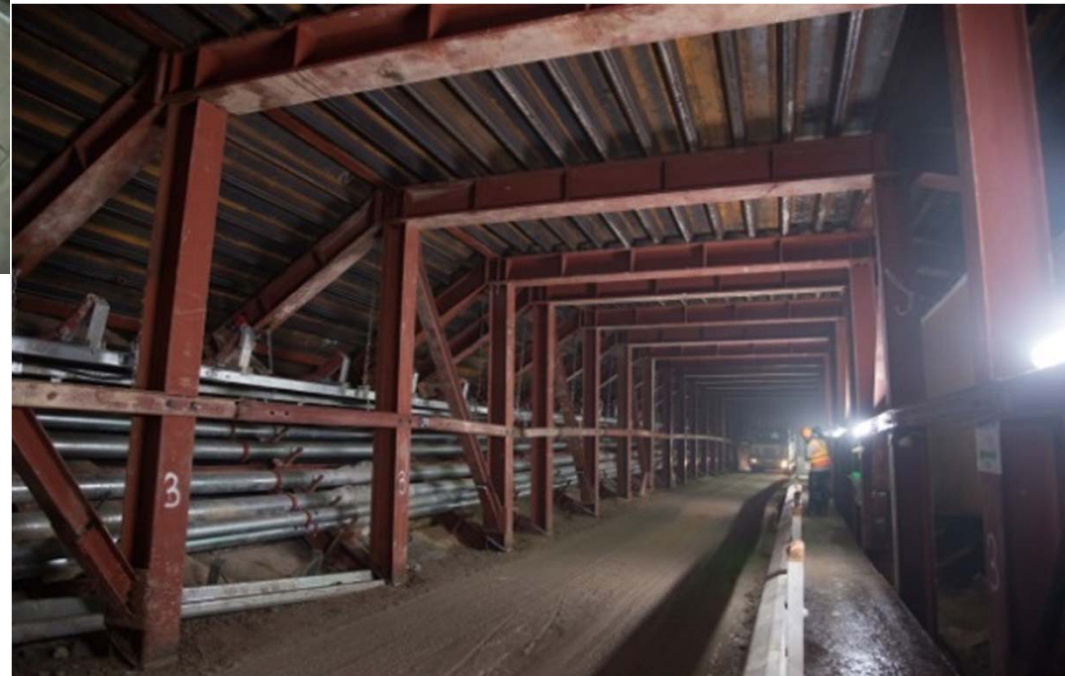
Photo 2 – The gallery provides a shelter for safe passage of construction vehicles underneath. Physical barriers added to separate vehicles from pedestrian access, and from the demolition and excavation work.

- ✓ Designated vehicles and pedestrians' accesses maintained to TBM. Physical barriers - to separate access from the demolition and excavation work
- ✓ Temporary Support - Excavation temporary support shall be installed immediately in each round of demolition and excavation to secure tunnel stability

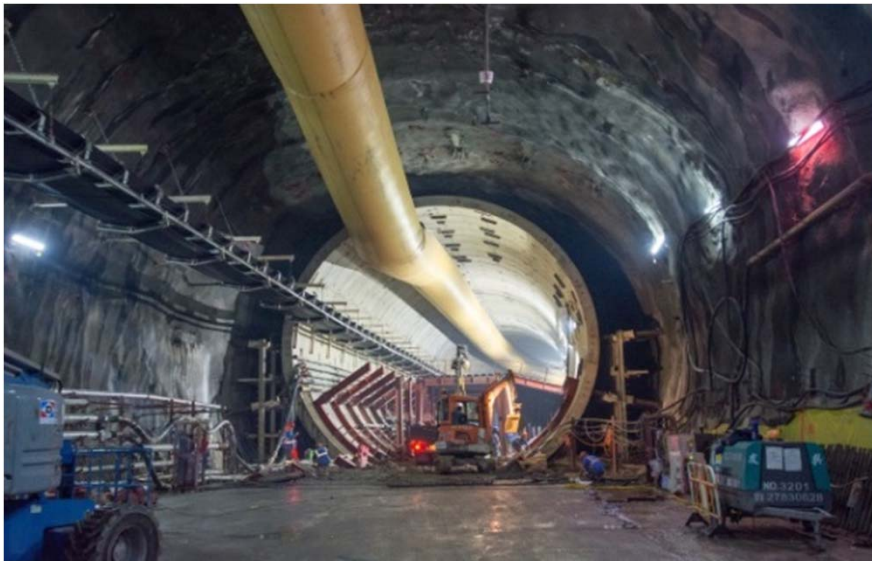
Photo 3 – Steel gallery is being erected inside built segmental lined tunnel

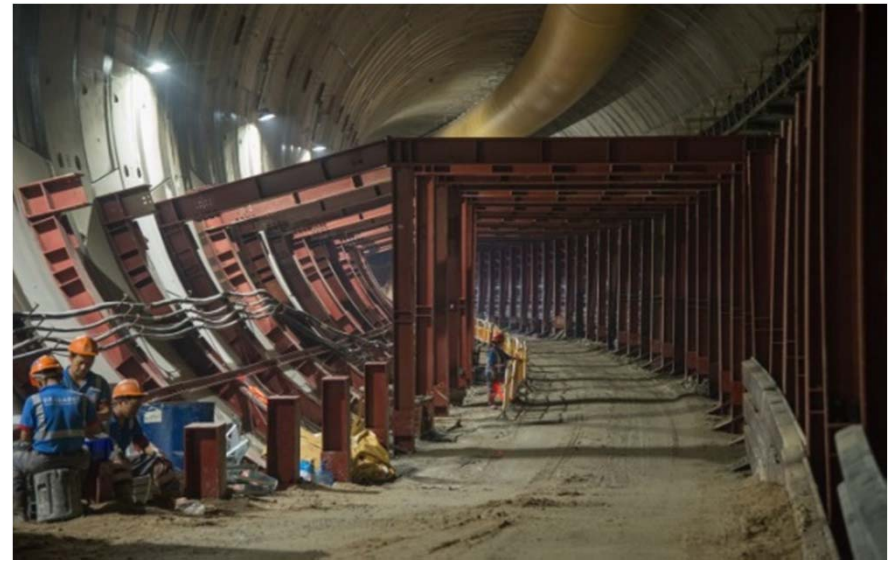
Photo 4 – Steel gallery being erected. It isolates the enlargement and demolition work face, in the upper deck, from the active access road underneath.

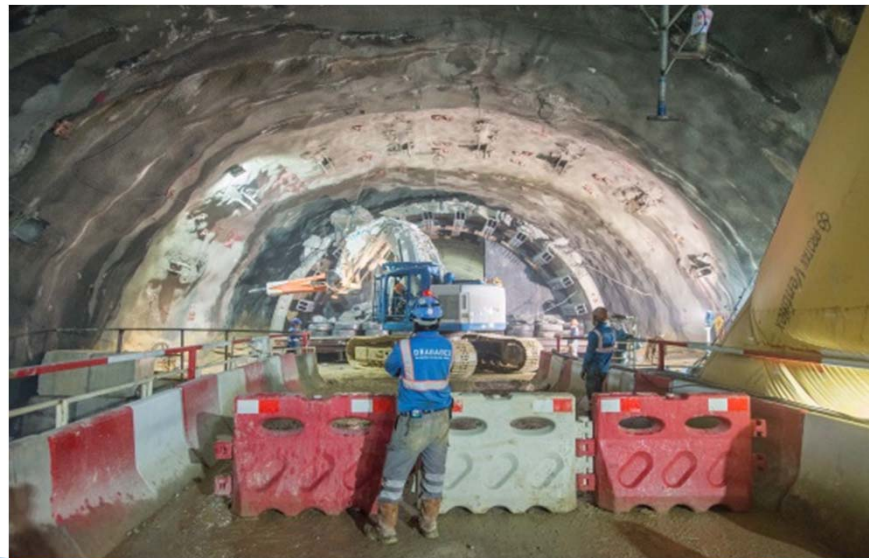
Photo 5 – Enlargement and demolition work face in the upper deck

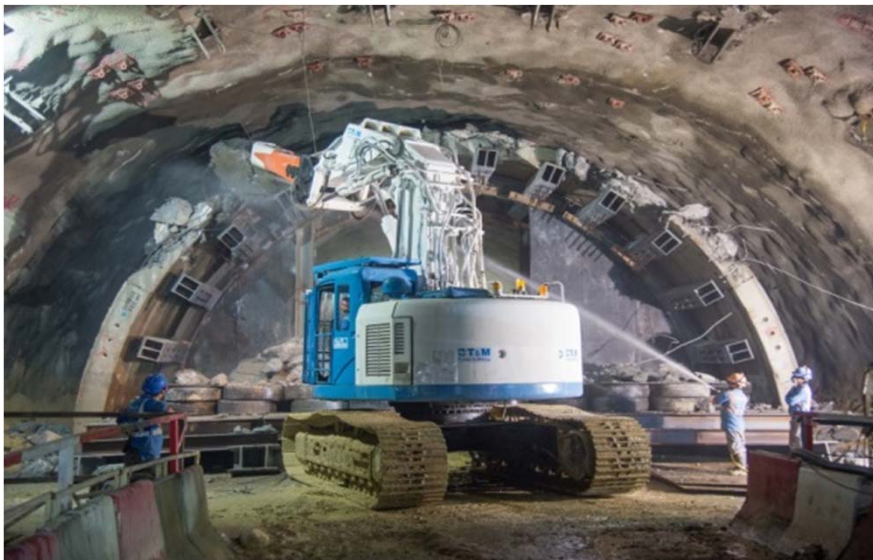
Photo 6 – To avoid overloading the gallery, Segment catching frame and cushions was designed to minimize the impact load. The size of falling segments could be controlled.

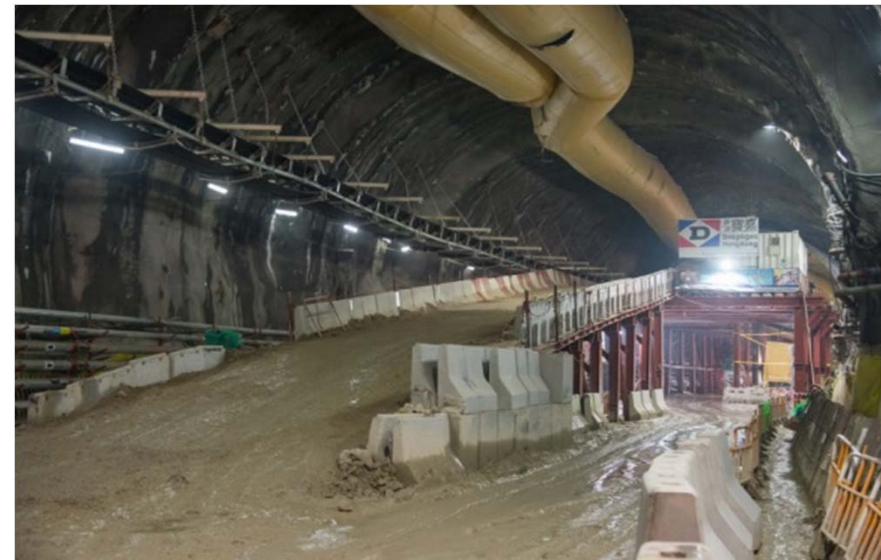
Photo 7 – Access Ramp to connect the enlargement and demolition work face, in the upper deck; and access road underneath to TBM.

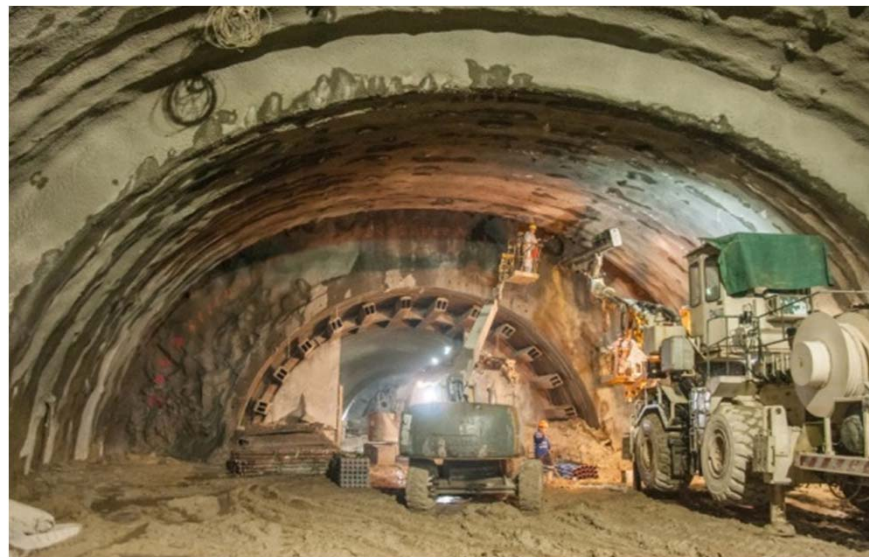
Photo 8 – Temporary Support Installation after each round of excavation and lining dismantling.
