# 特殊複式吊索 Slingmax

Three Runway System Project  
Contract 3302 Eastern Vehicular Tunnel Advance Works

# Slingmax Synthetic Sling (Single-Path Roundslings)

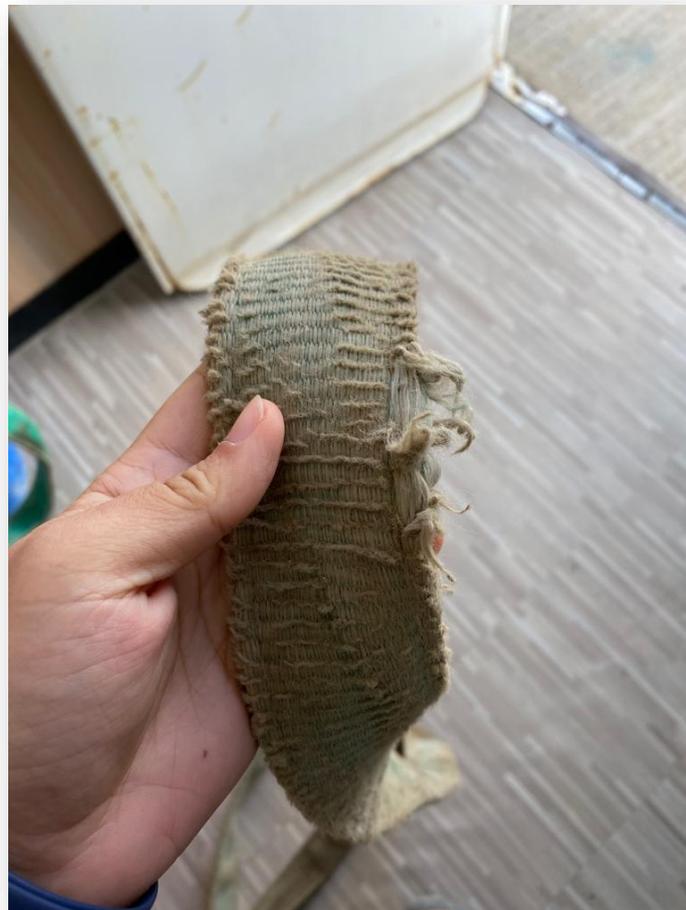
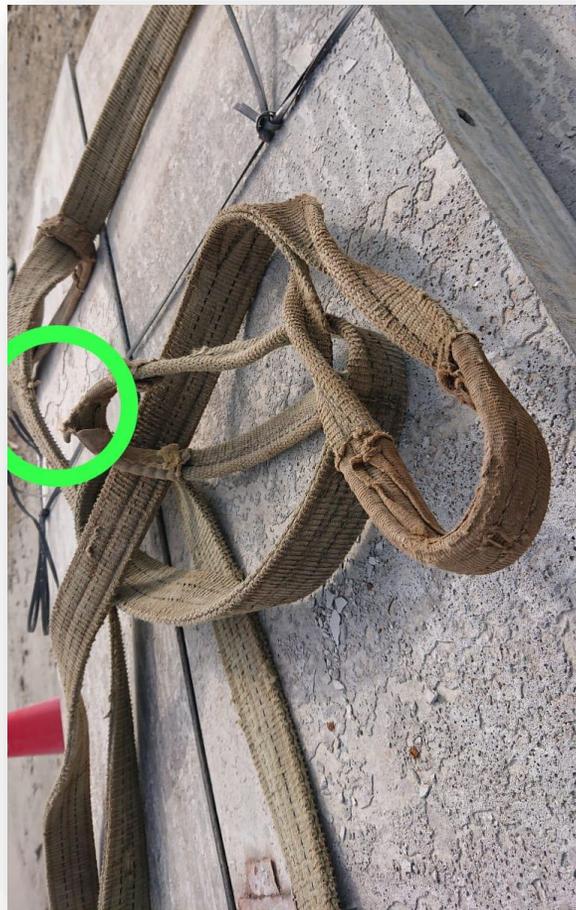
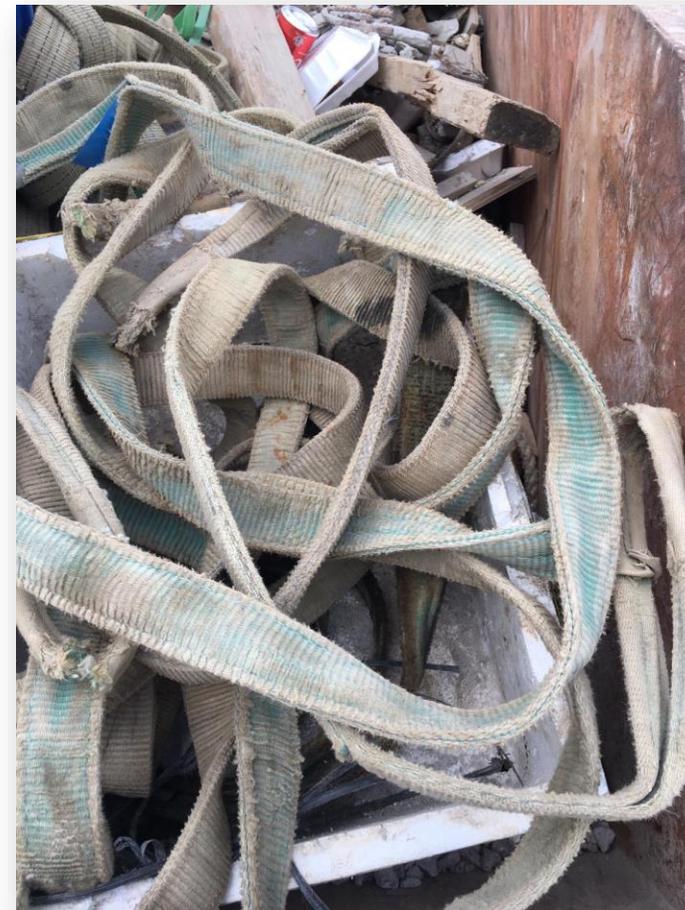
How to identify if the webbing sling is fit for use or not? Overload? Damaged?

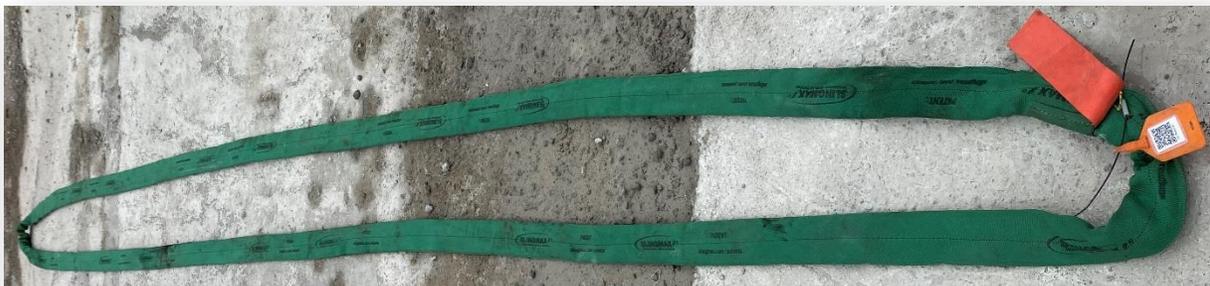
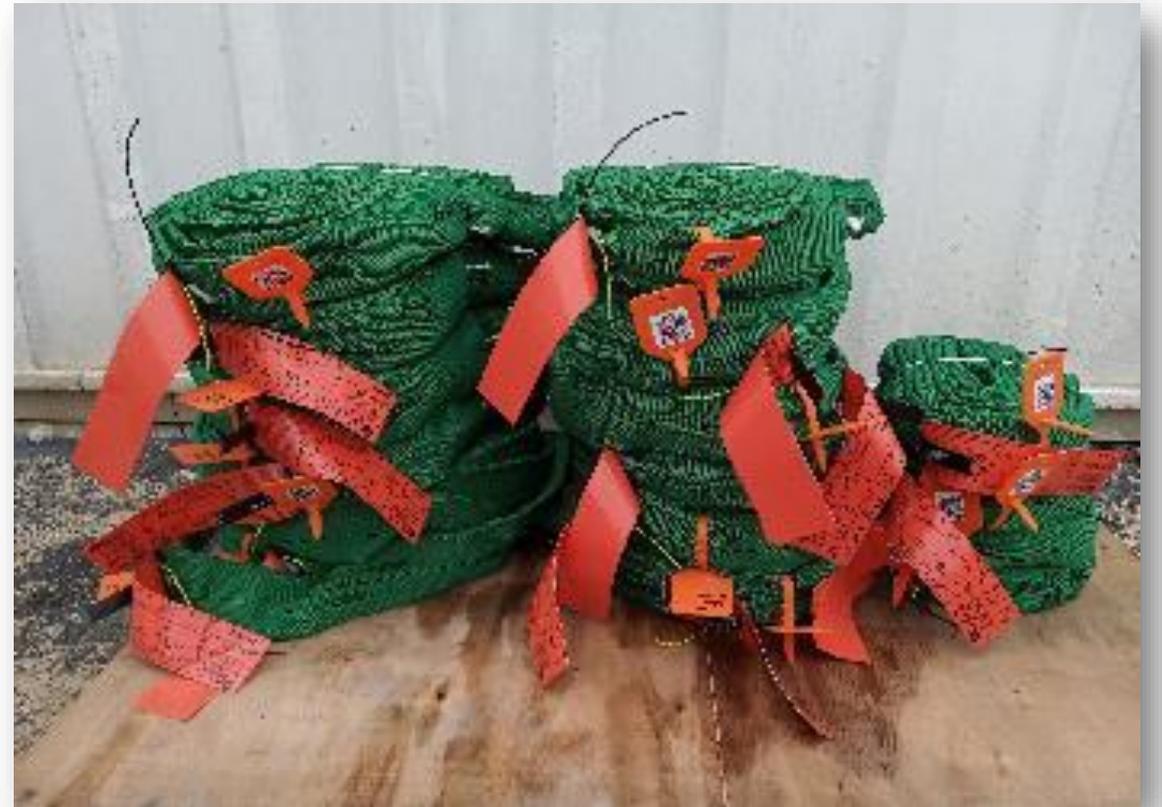
## Slingmax Synthetic Sling (Single Path)

- Length: 6m
- S.W.L.: 2T

- General site material
- Vertical lifting of bended rebar
- Concrete pipe

6m (L), S.W.L.: 2T	Traditional Webbing Sling	Slingmax Synthetic Sling (Single Path)
<b>Sling</b>	1 layer	2 layers
<b>Weight</b>	Similar	
<b>Inspection method</b>	Physical damage	Optical fiber Magic string Physical damage
<b>Application</b>	Lightweight general site materials	Heavy load in one unit
<b>Price</b>	~\$120	~\$1200

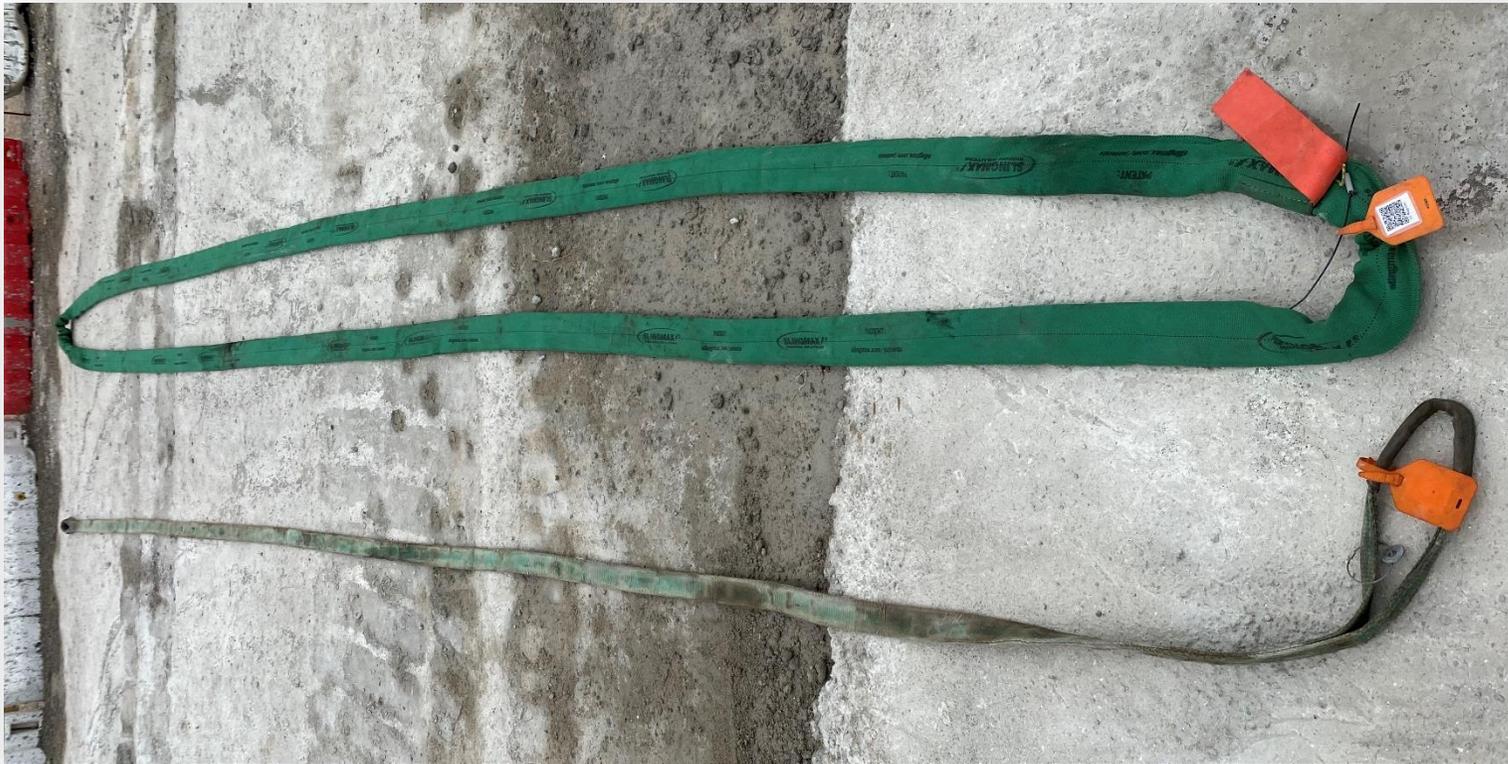
# Slingmax V.S. Traditional Webbing Sling

**Slingmax - Length: 6m; S.W.L.: 2T**

**Main differences of Slingmax**

- Compose of two layers
- Round sling
- Thicker
- Wider

**Traditional Webbing sling - Length: 6m; S.W.L.: 2T**

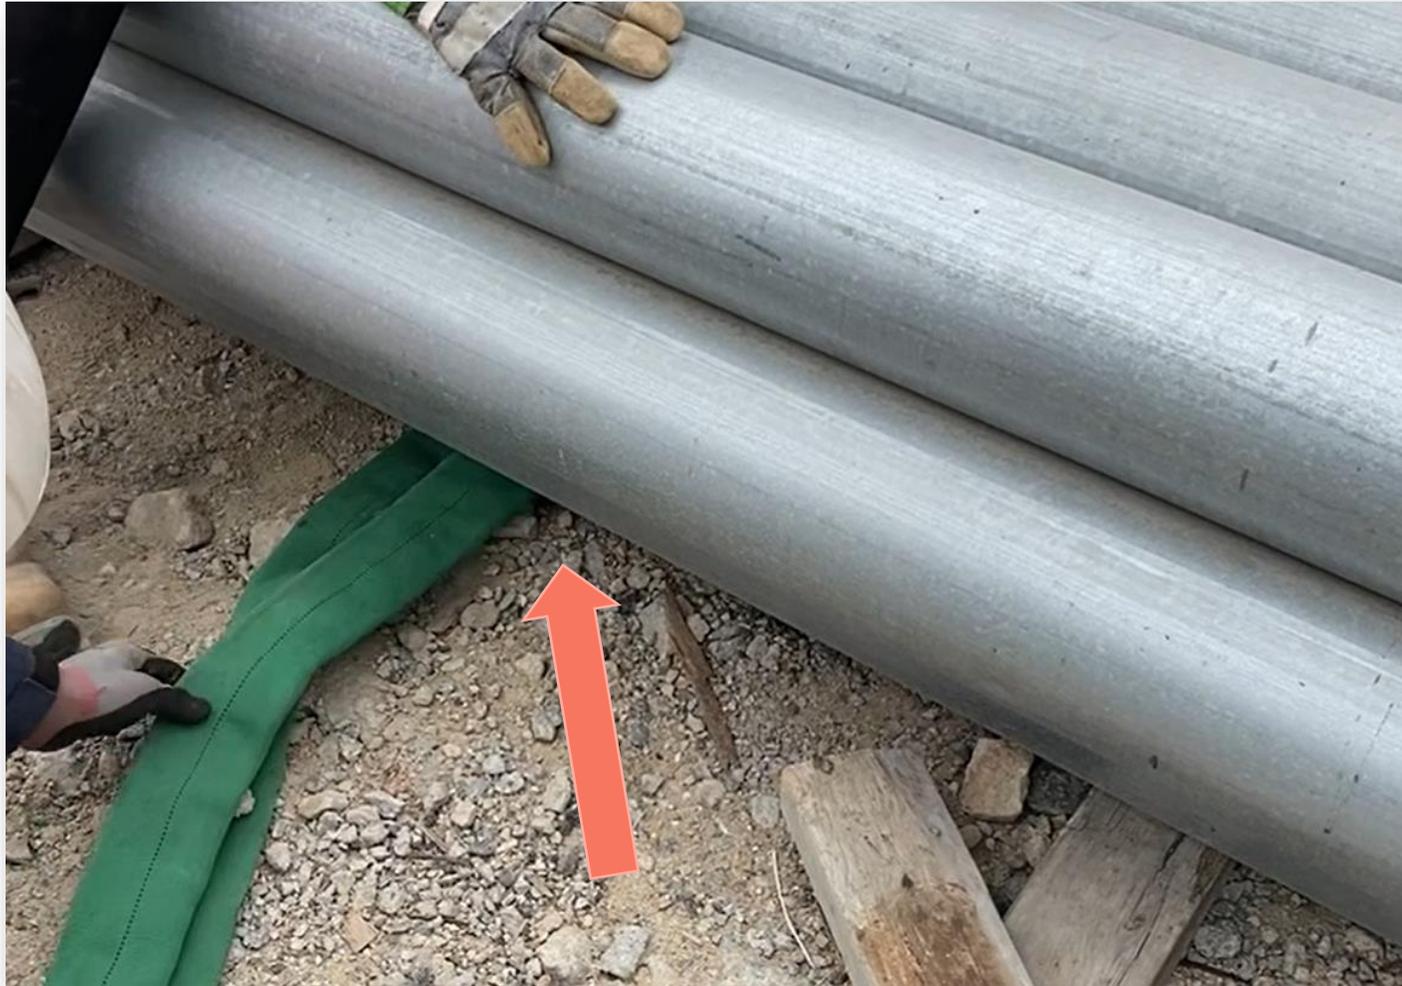
# Application on Lifting of General Site Materials

- ◆ Harder to pass underneath the materials
- ◆ Need to provide a specific training for rigger

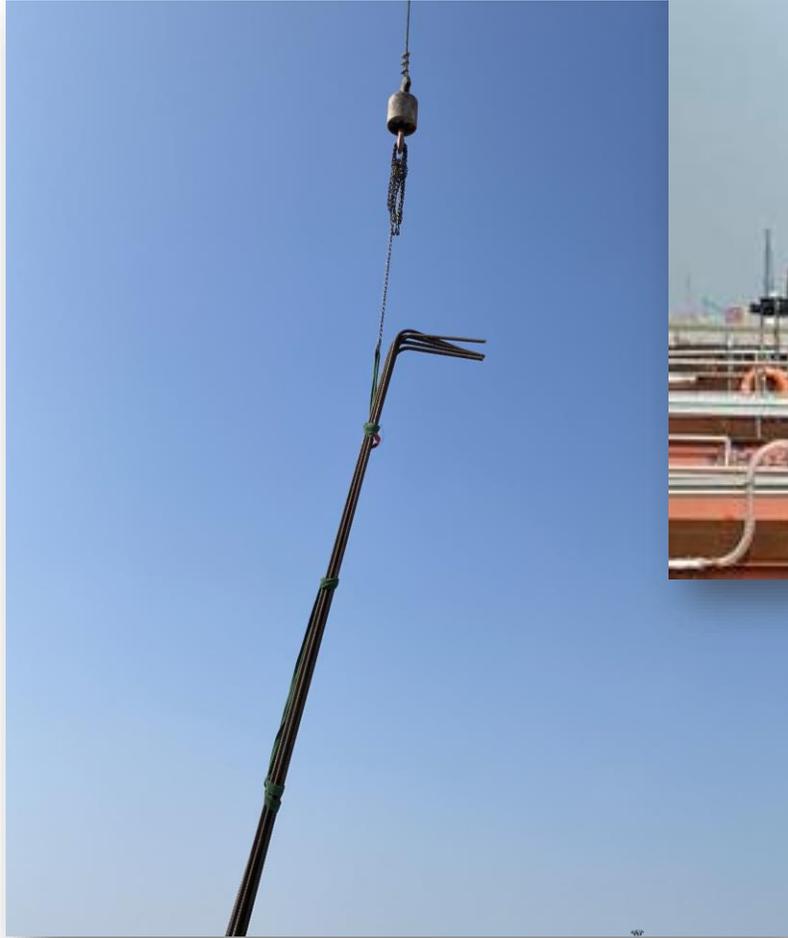
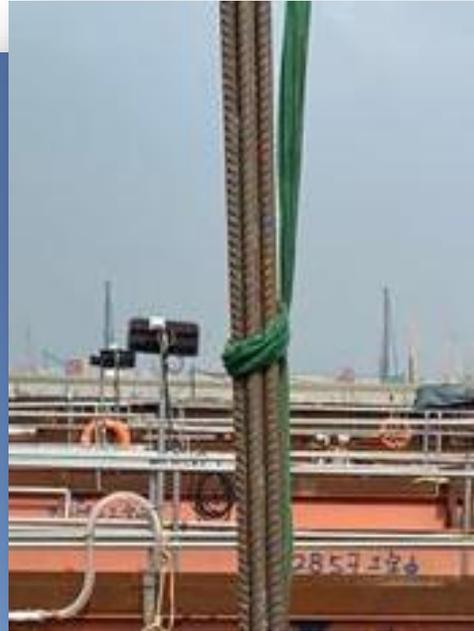
# Application on Vertical Lifting of Bended Rebar

- ◆ **Secure**
- ◆ **Not easy to be scratched by the rebar**

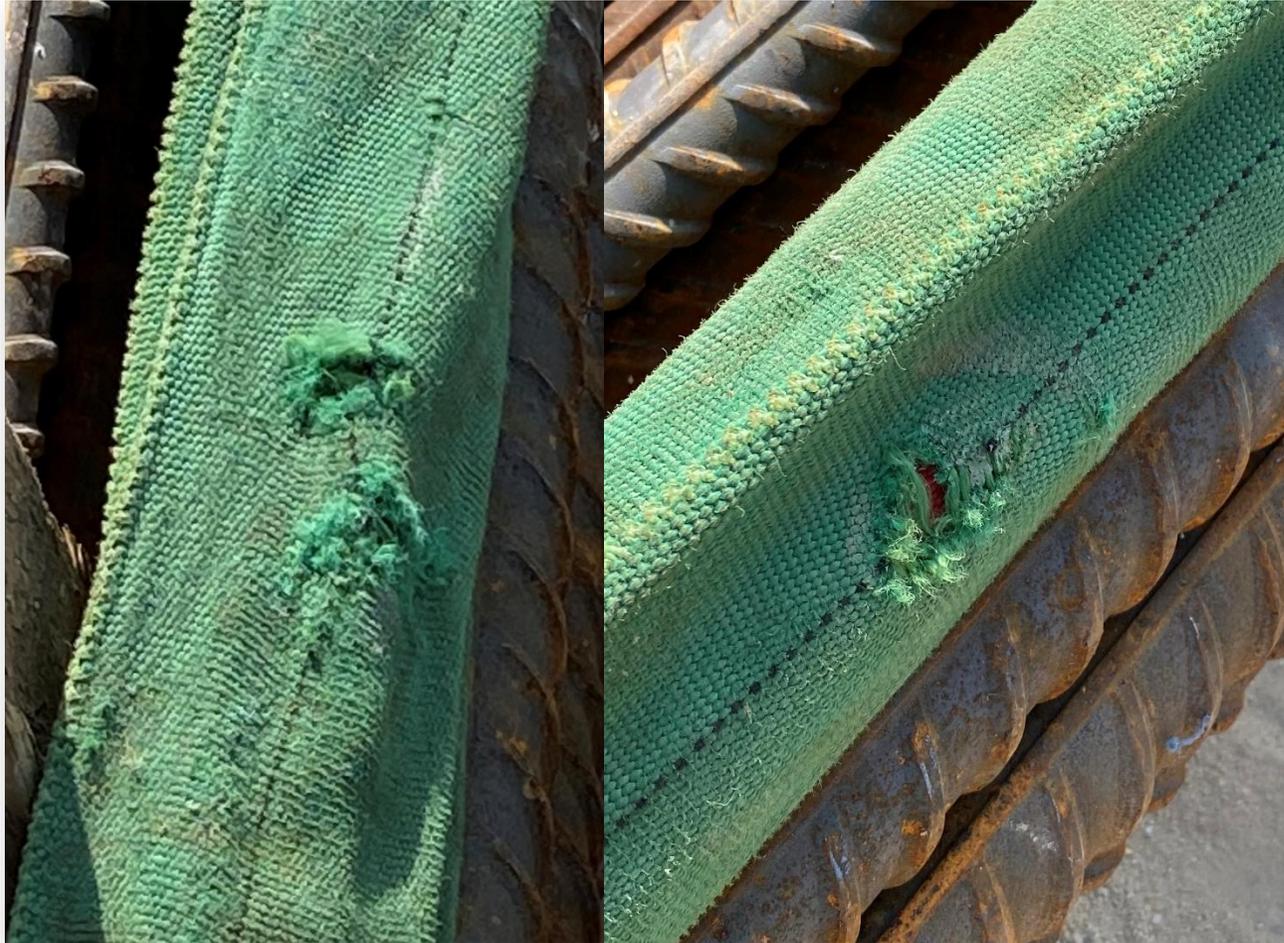
# Application on Vertical Lifting of Bended Rebar

- ◆ Little holes were observed after using for 5 months

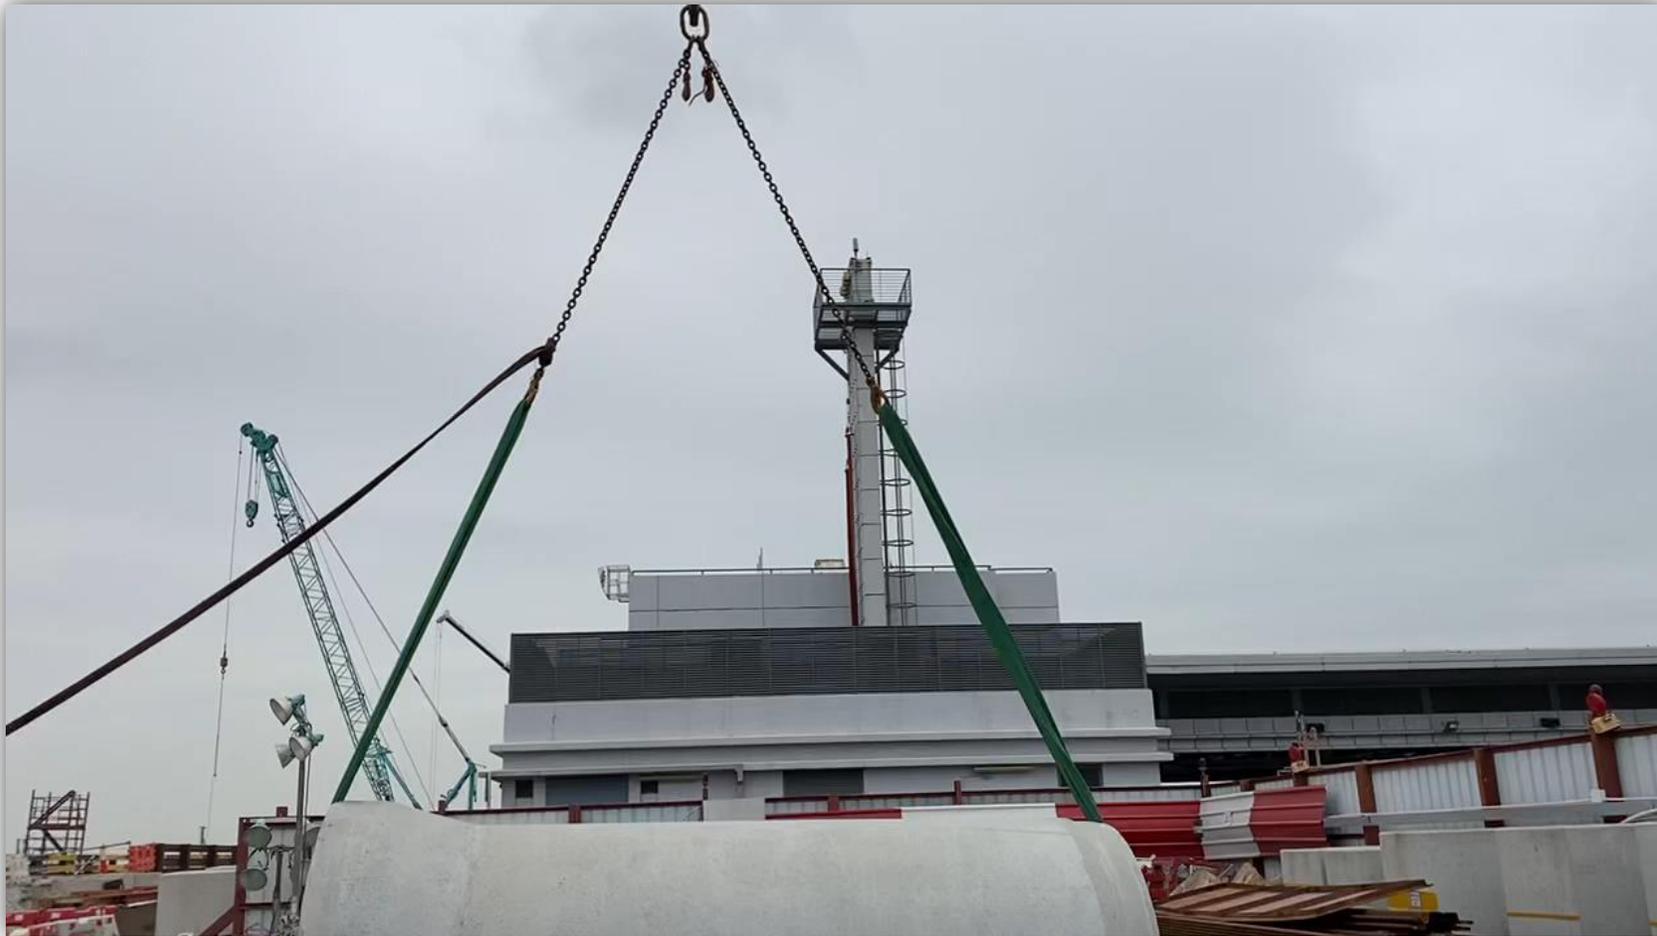
# Application on Lifting of Concrete Pipe

- ◆ Slingmax is wider and softer
- ◆ Not easy to damage the concrete pipe

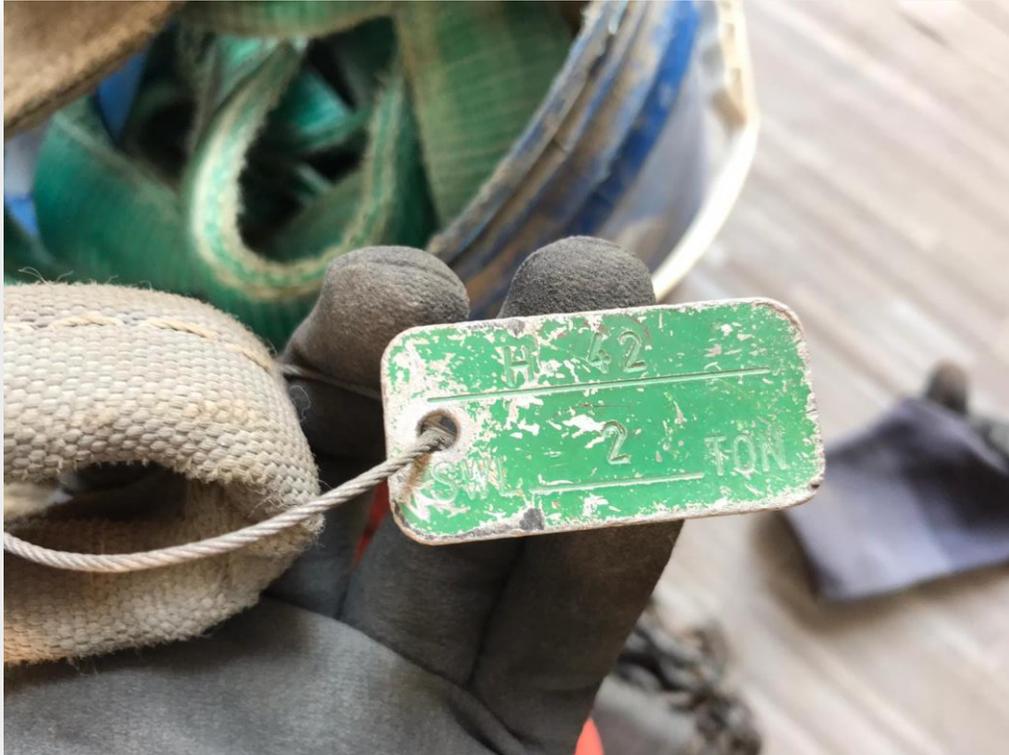
## Tradition

- Marking is easy to lose
- Hard to see the marking

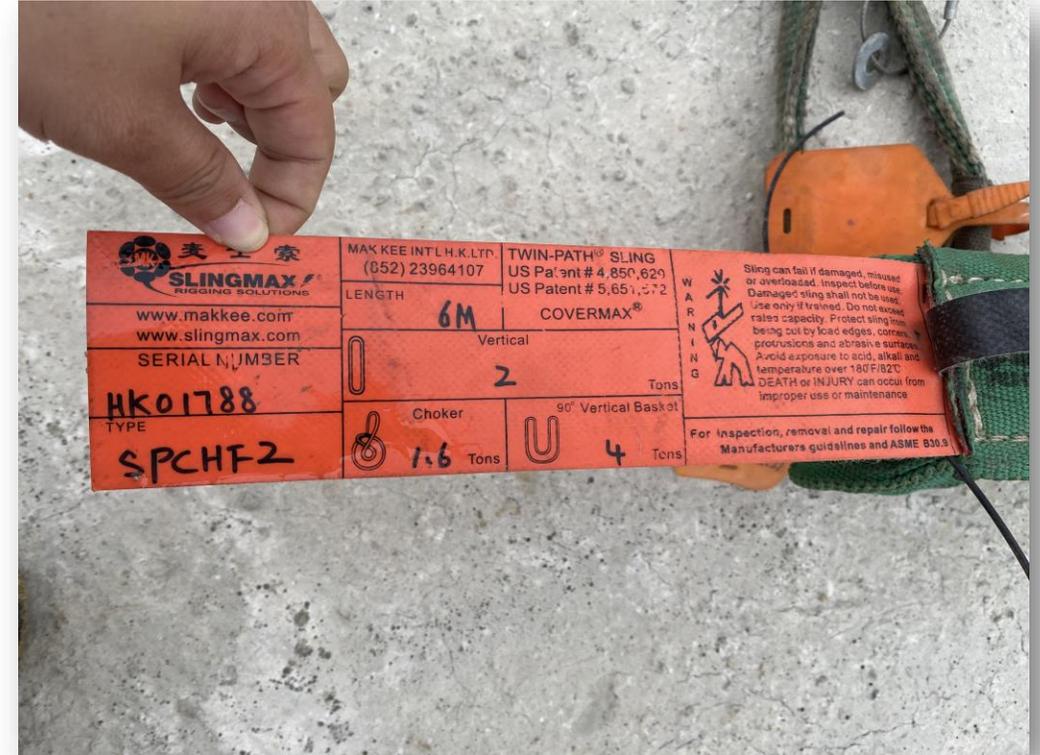
## Slingmax

- Marking is stitched on the sling
- Clear marking

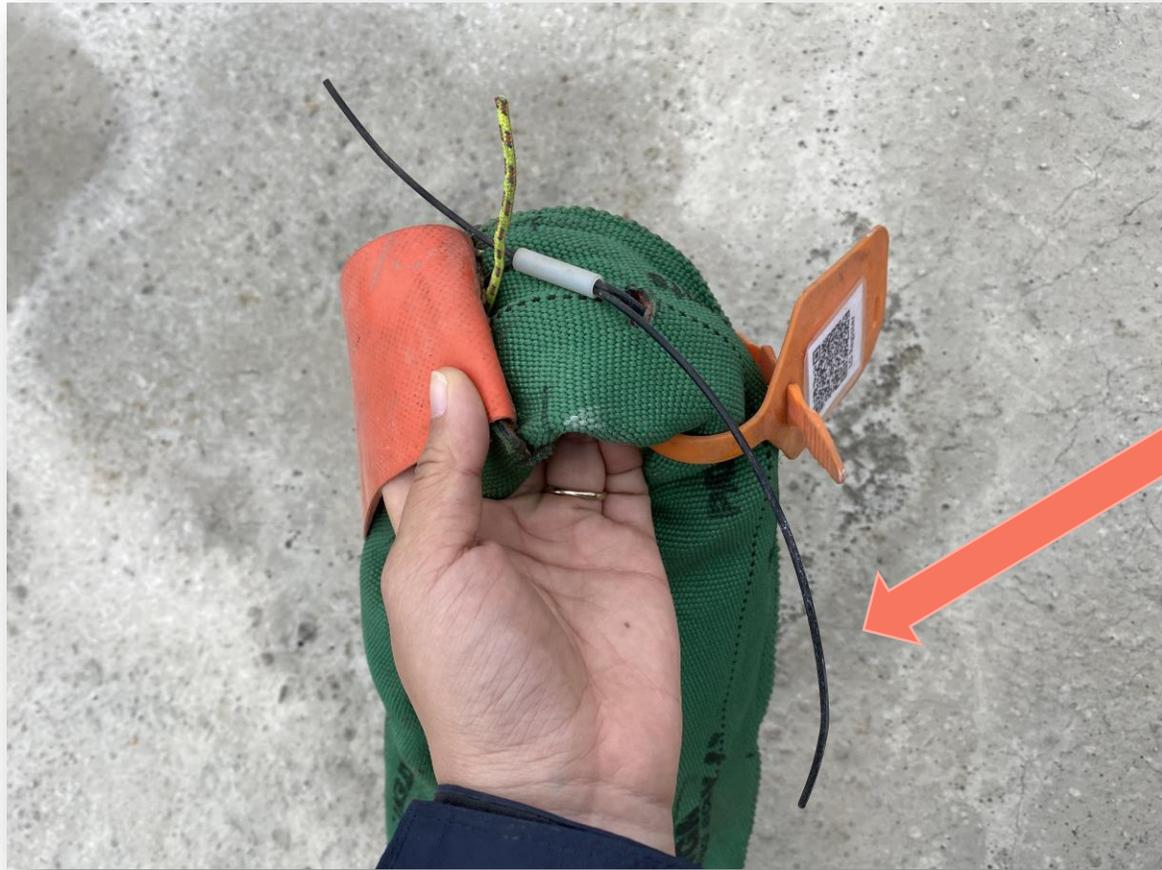
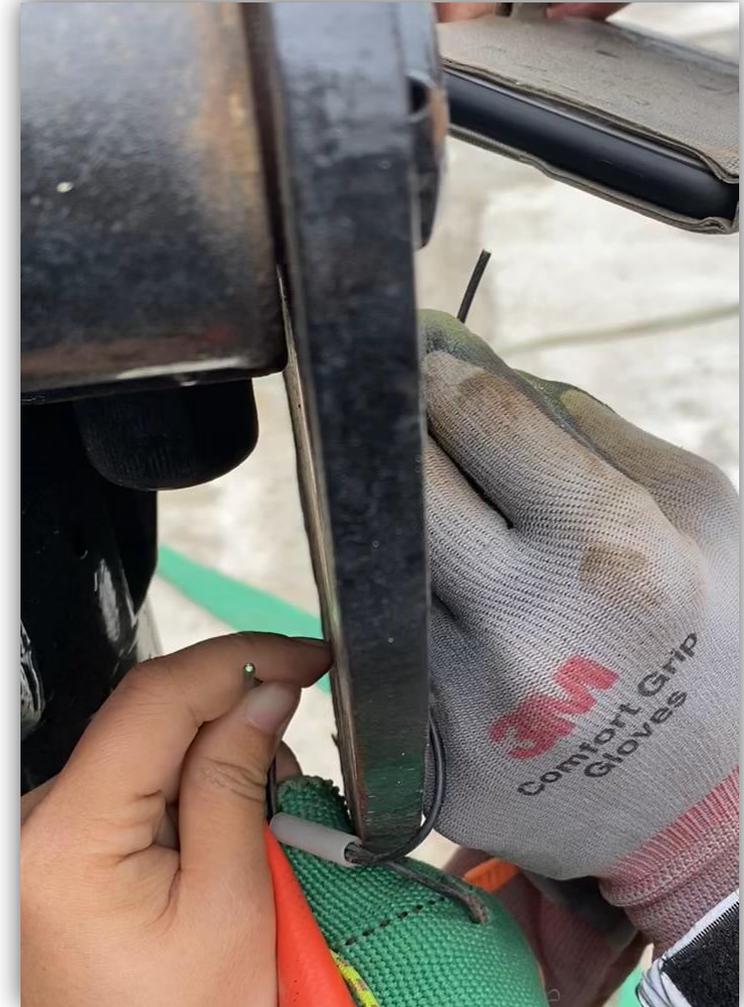
# Check-Fast® Inspection System

If damage: Optical Fiber **No light -> Stop**

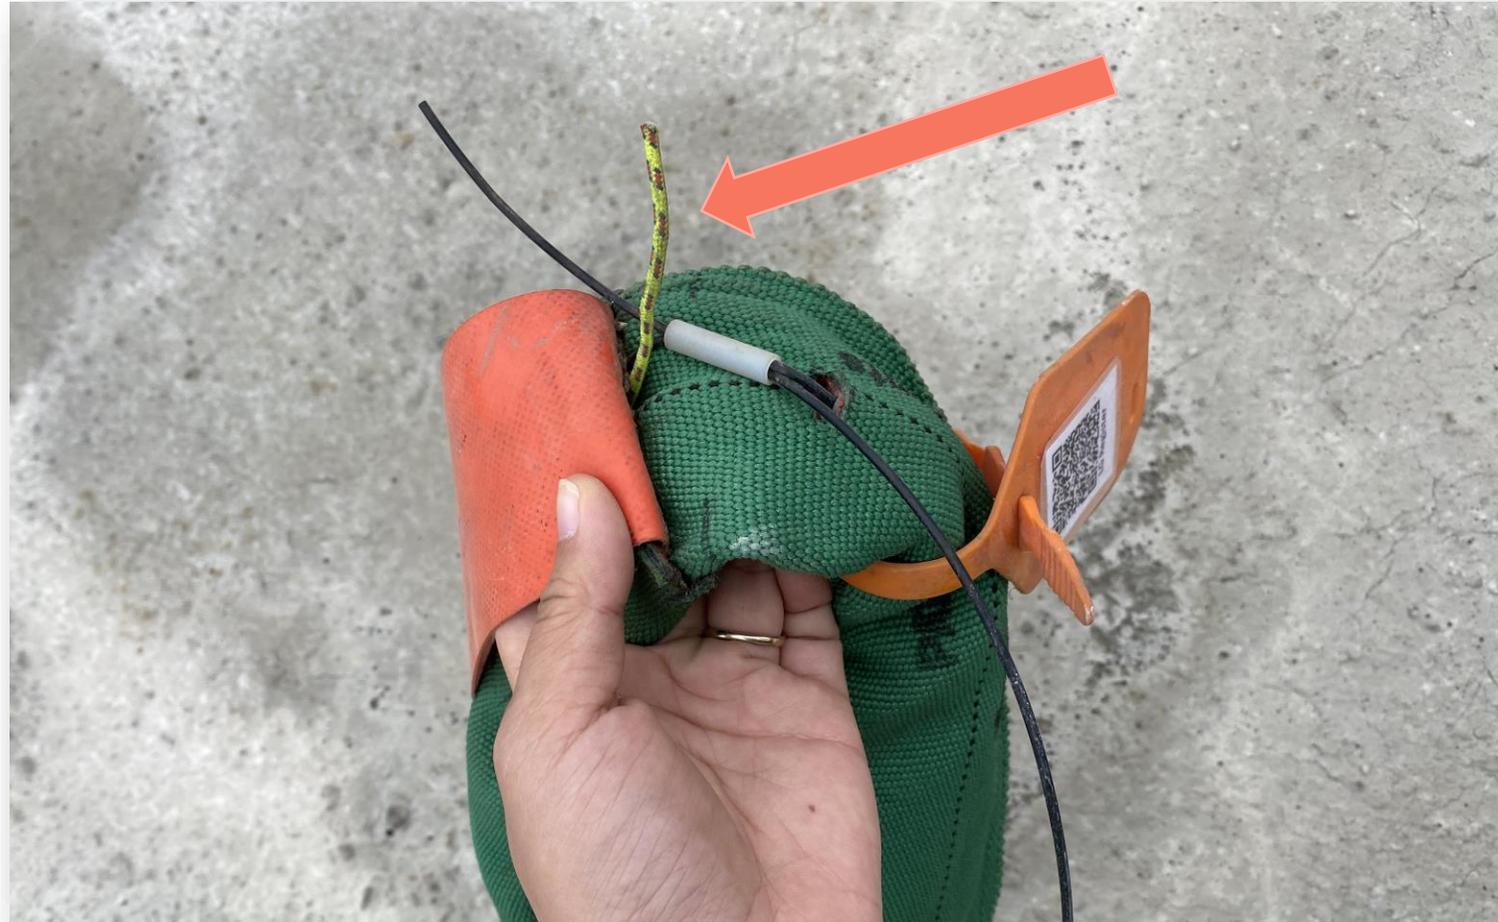
# Check-Fast® Inspection System

**If overload: Magic String (EWI) Gone -> Stop**
